Fintray Church Bat Survey

Fintray Church

Bat Survey

Document number: 7741
Project number: 369668
Status: Final

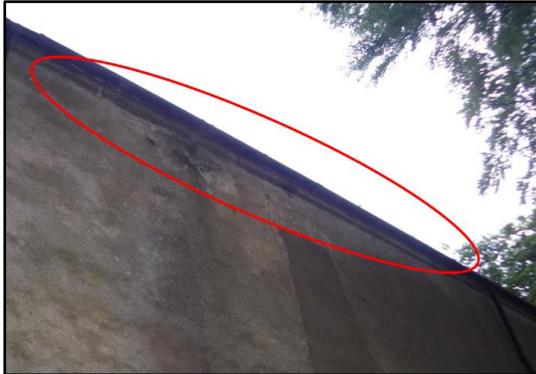
- Gaps under slates and missing slates on the roof;
- Gaps under the roof ridge;
- Deteriorating masonry at the wall-head and gutter line (Photo 1);
- Raised lead flashing
- Three bat droppings, thought to be from pipistrelle bats were found on the windows on the west aspect of the extension (Photo 2).

Photo 1: Example of deteriorating masonry at wall head and under guttering.

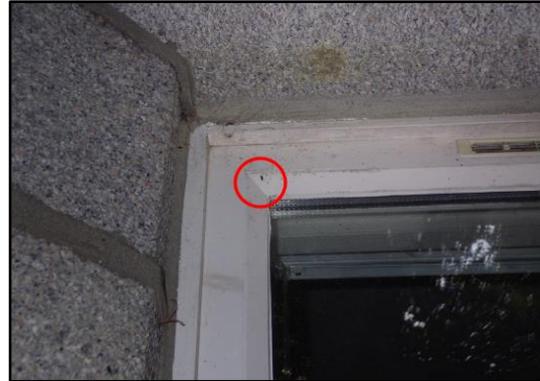
Photo 2: Pipistrelle dropping located on west aspect of new extension.

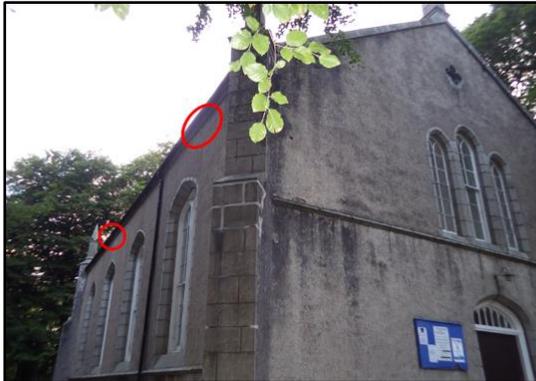
- Two common pipistrelle and 20 brown long-eared bats were seen emerging from the wall-head void behind the guttering on the southern aspect of the building (Photo 3).
- A single bat was seen emerging from the wall-head void behind the guttering on the northern aspect of the building (Photo 4). It was not echolocating as it emerged and no identifying features/characteristics were clearly observed. Timing of emergence (50 min after sunset) and lack of echolocation suggests this was a brown long-eared bat.
- A number of common and soprano pipistrelles were observed foraging in trees around the building throughout the duration of the survey, with brown long-eared bats observed foraging in the latter half of the survey.

- One common pipistrelle and 38 brown long-eared bats were seen entering the roost at the wall-head void behind the guttering on the south aspect of the building (Photo 3).
- A number of common and soprano pipistrelles, brown long-eared bats and Daubenton's were observed foraging throughout the duration of the survey.

Photo 3: Roost exit points identified during the dusk survey (dusk: 2 common pipistrelles from exit on left, 20 brown long-eareds from exit on right, dawn: 38 brown long-eared and 1 common pipistrelle entered on right).

It is not clear at present whether the planned works will affect the roost access points currently being used by the bats at the wall-head void behind the guttering (as indicated in Photos 3 and 4). The preferred option is to leave these intact. If works are going to impact the access points, they should be re-instated similarly to the drawing in figure 5-1.

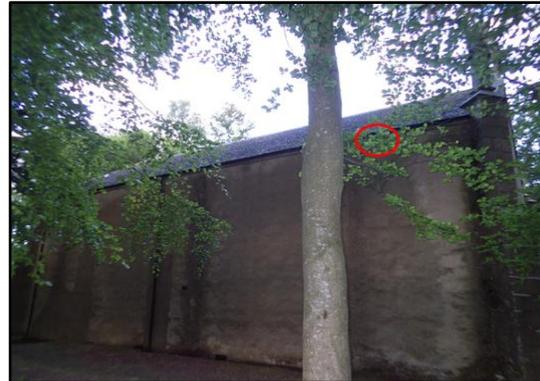
Photo 4: Brown long-eared exit point on north aspect.
